Effects of Temporary Overvoltage on Residential Products

System Compatibility Research Project

Technical Report

Final Report, March 2005

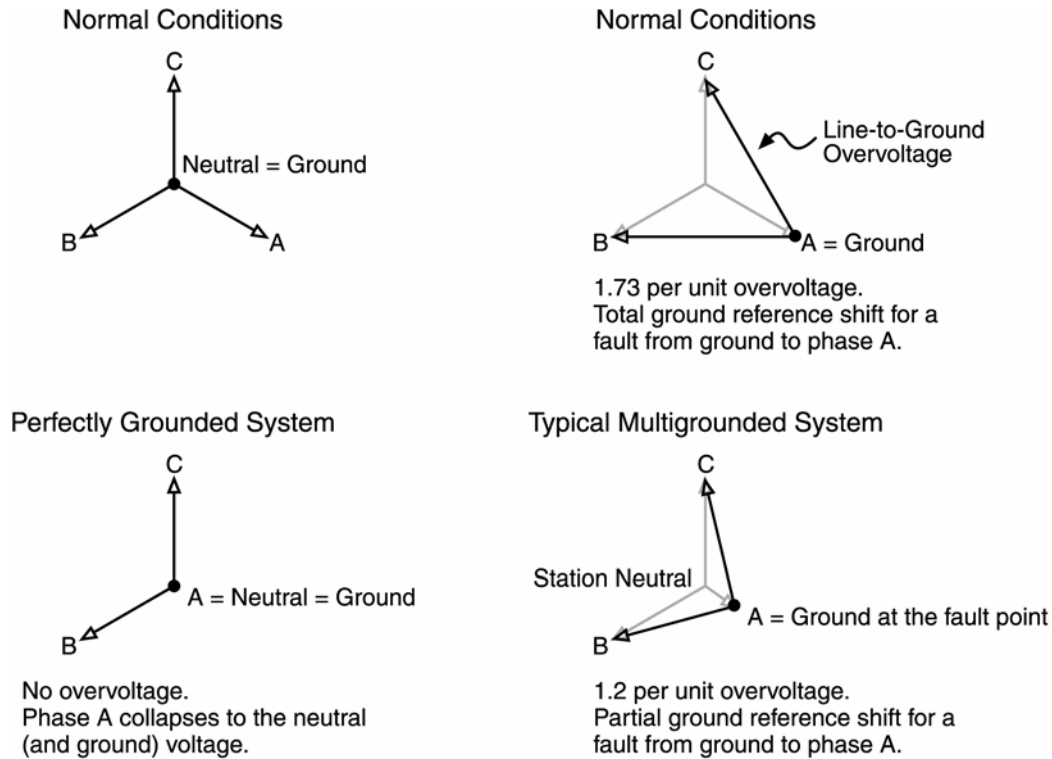
Figure 2-1
Shifts in Ground Potential and Overvoltages Depending on the Grounding Configuration

The system grounding configuration determines the overvoltages that can occur during a line-to-ground fault. A single line-to-ground fault shifts the ground potential at the fault location. The severity of this shift in ground reference depends on the grounding configuration (see Figure 2-1). On a solidly grounded system with a good return path to the grounding source, little reference shift occurs. On an ungrounded system, a full offset occurs—the line-to-ground voltage on the unfaulted phases rises to the line-to-line voltage, which is 1.73 per unit. On a multigrounded distribution system with a solidly grounded station transformer, overvoltages above 1.3 per unit are rare.

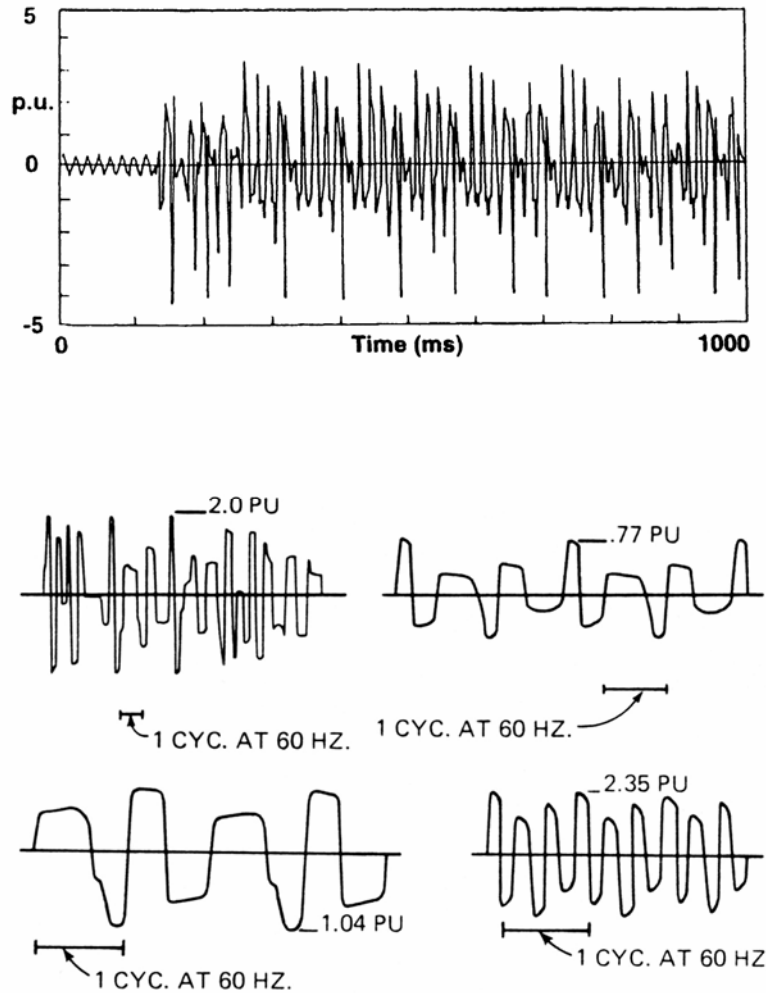
Figure 2-5
Examples of Ferroresonance [6], [7]

Ferroresonance is a special form of series resonance between the magnetizing reactance of a transformer and the system capacitance. A common form of ferroresonance occurs during single phasing of three-phase distribution transformers [5]. This most commonly happens on cable-fed transformers because of the high capacitance of the cables. The transformer connection is also critical for ferroresonance. An ungrounded primary connection (see Figure 2-4) leads to the highest magnitude of ferroresonance. During single phasing (usually when line crews energize or de-energize the transformer with single-phase cutouts at the cable riser pole), a ferroresonant circuit between the cable capacitance and the transformer's magnetizing reactance drives voltages to as high as five per unit on the open legs of the transformer. The voltage waveform is normally distorted and often chaotic (see Figure 2-5).

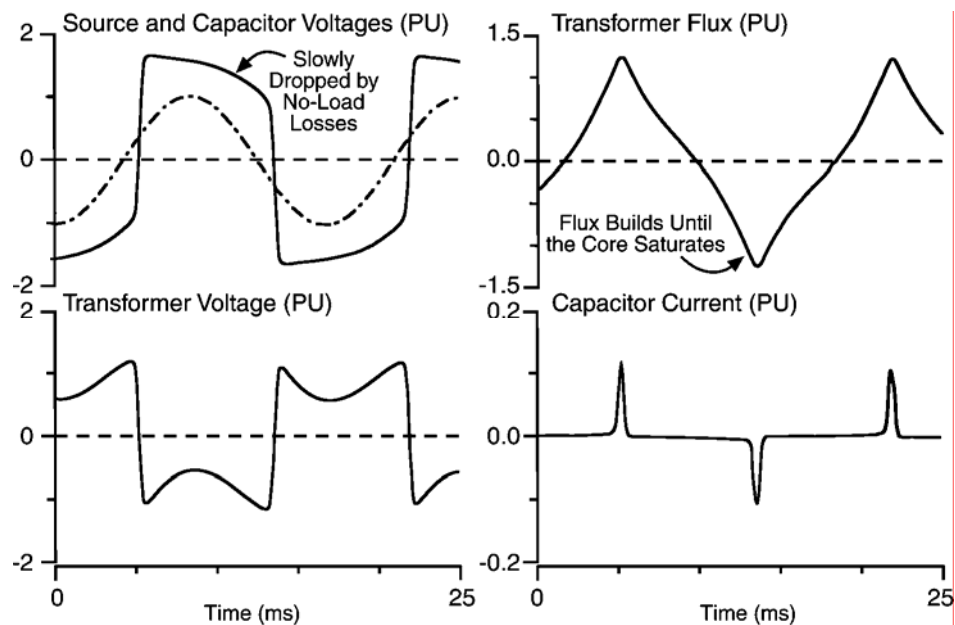
Figure 2-7
Voltages, Currents, and Transformer Flux During Ferroresonance

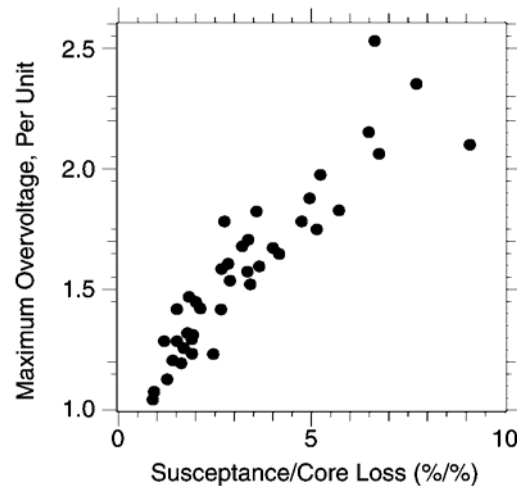
Figure 2-8
Five-Legged Core Ferroresonance as a Function of No-Load Losses and Line-to-Ground Capacitance

Five-legged core ferroresonance also depends on the core losses of the transformer and the phase-to-ground capacitance. If the capacitive vars exceed the resistive load in watts, ferroresonance may occur. Higher capacitances—longer cable lengths—generally cause higher voltages (see Figure 2-8).

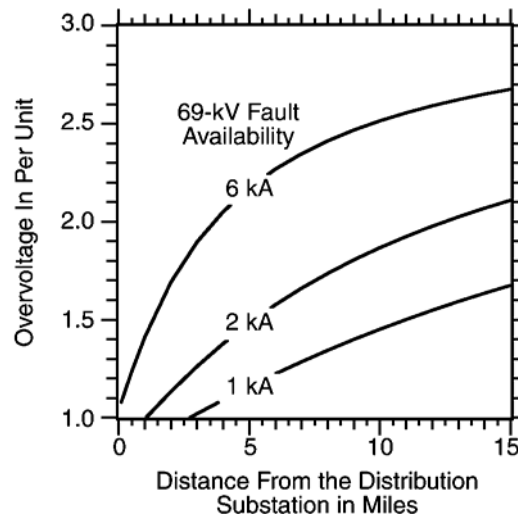
Figure 2-10
Results of Simulations of a Fault From a 69-kV Circuit to a 12.5-kV Circuit (Before the Distribution Substation Breaker Trips)

Figure 2-10 shows results from a series of computer simulations on a 12.5-kV circuit for various fault locations and subtransmission source stiffnesses. Results only modestly differ for other configurations: a 69-kV source in the opposite direction, a looped transmission source, a different substation transformer configuration, or different phases faulted. The worst cases are for stiff transmission systems.

In this situation, distribution transformers would saturate, and metal-oxide arresters would move into heavy conduction. Transformer saturation distorts the voltage but does not appreciably reduce the peak voltage. Arresters can reduce the peak voltage, but they could still allow quite high voltages to customers. Arresters with an 8.4-kV maximum continuous operating voltage start conducting for power-frequency voltages at about 11 to 12 kV (1.5 to 1.6 times the nominal system line-to-ground voltage). At higher voltages, the arresters will draw more current.

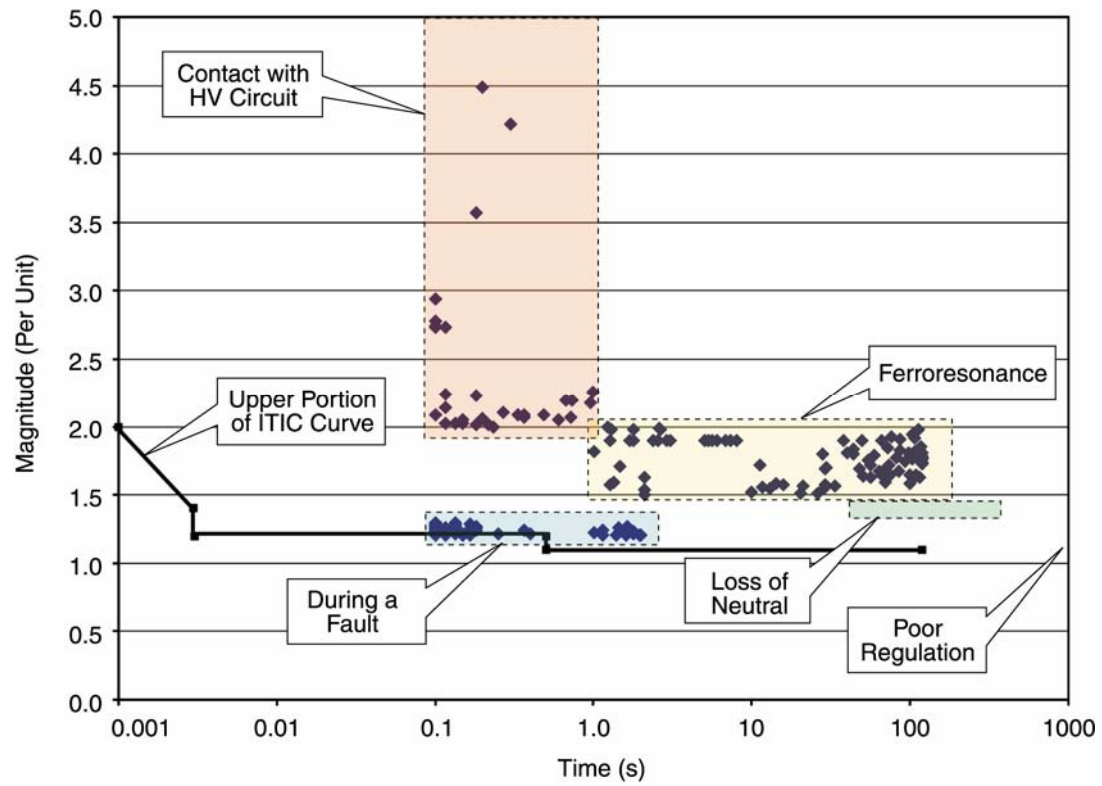
Figure 3-3
TOV Events Grouped by Query Results

In Figure 3-3, data points from both EPRI DPQ surveys are combined into one graph. Additionally, bounding rectangles show the relative positions of the five queries. Note that the events due to poor regulation fall outside the graph area because of their long durations. An additional feature of this figure is the upper portion of the ITIC curve shown for reference. The Information Technology Industry Council (ITIC) publishes a well-known curve representing the expected tolerance (no interruption in performance or failures) of computer equipment. It is not intended to be a design criterion for equipment or the AC power system. Only the portion of the curve that fits into the time window is shown.

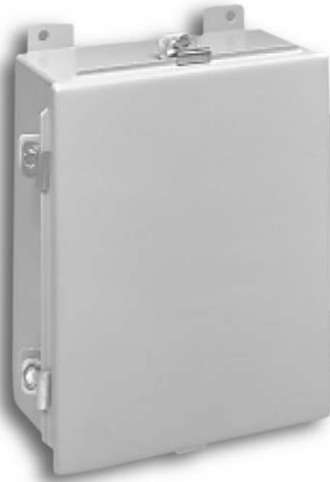
Figure 4-6
Example of a Permanently Connected SPD

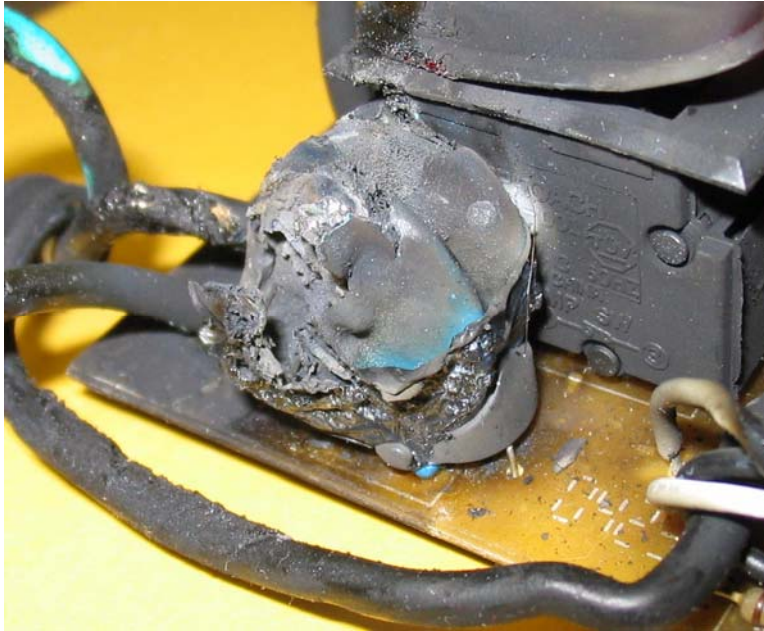
Figure 6-1
Crispy Factor of CF3, Indicating Obliteration

Crispy Factor	Description	Example
CF3	Large chunks of MOV fall off the circuit board with very little coercion.	Figure 6-1
CF2	MOV flaky over $\frac{1}{2}$ to $\frac{3}{4}$ of its surface.	Figure 6-2
CF1	MOV has one large hole or split but is still structurally sound.	Figure 2-1
CF0	Not crispy. Structurally sound. Might or might not be covered with soot from nearby MOVs. Appears to be a working MOV.	Figure 6-4

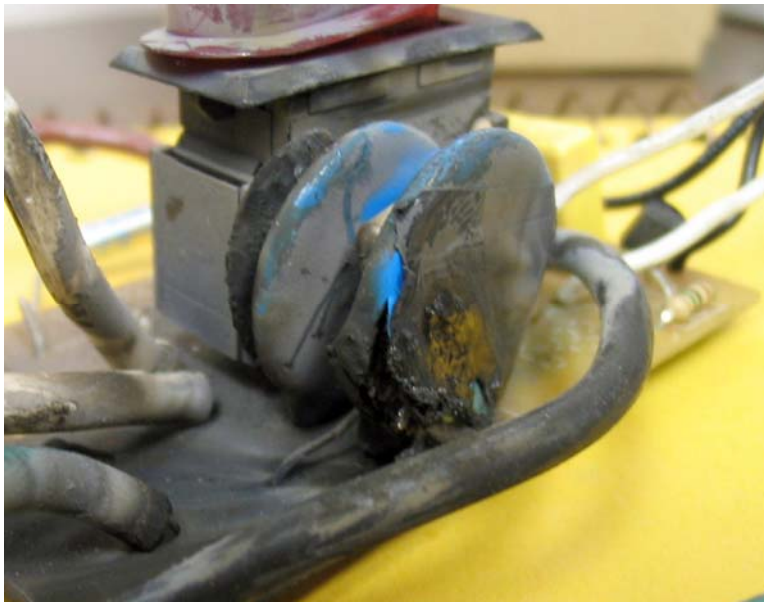
Figure 6-2
Crispy Factor of CF2, Indicating a Flaky Surface and Some Loss of Physical Structure

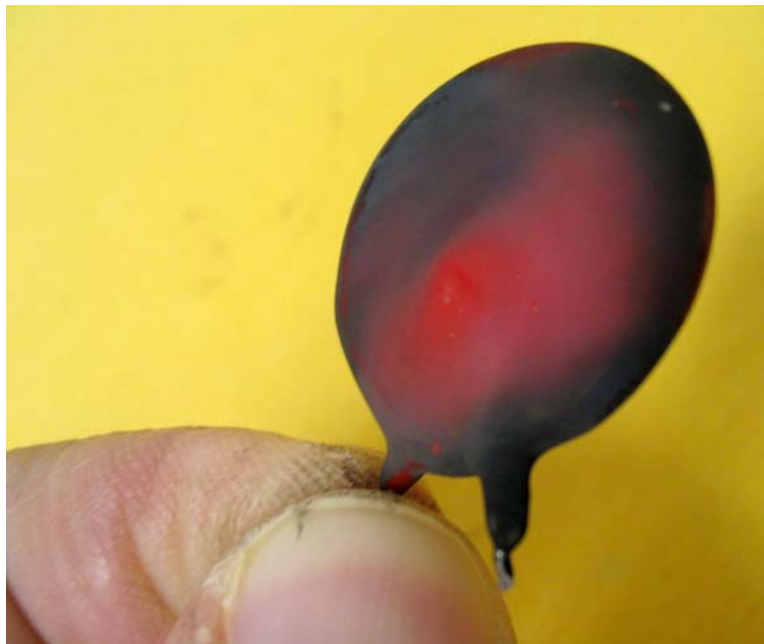
Figure 6-4
Crispy Factor of CF0, Indicating an Intact MOV Even If Covered With Soot From Other MOVs

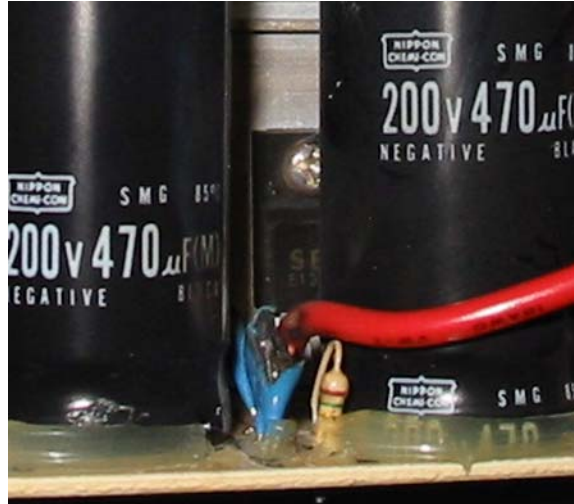
Figure 6-7
MOV Failure Inside the Computer Power Supply of PC4

Type	Test 4	Test 5
	240 V – 1 Minute	360 V – 1 Second
PC	Input fuse open Small MOV failed open See Figure 6-7	Input fuse open. Fuse replaced. Power supply functional with new fuse.
Monitor	Apparent failure, but monitor worked normally when nominal voltage was applied.	Input fuse open. Fuse replaced. Monitor functional with new fuse.
